Fact Sheet for Corrective Measures Study SWMU 8 – Landfill IV

Description: SWMU 8, also known as former Landfill IV, is a 140-acre area that was the primary disposal site for wastes generated from the various operating areas of Chambers Works from approximately 1940 to 1975. These wastes included solid and semi-solid wastes (bulk sludge and tars, basin and river dredgings, spent carbon and catalyst, fly ash, drummed powders, and asbestos), empty containers, construction debris and building rubble, trash and general refuse, soil fill, and liquid wastes (waste oil, spent solvents, etc.) and discarded machinery and equipment. A majority of these wastes were disposed in bulk form, however some wastes were disposed of in drums (steel or cardboard), barrels, or other containers. Operation of Landfill IV was the responsibility of the Chambers Works S&T Department. The S&T Department used approximately 21 narrow gauge sludge cars and 175 waste hoppers to collect process waste from all operating areas of Chambers Works for transport to Landfill IV (DuPont, 1969). In addition, the S&T Department managed activities within the Landfill IV area (now designated as SWMU 8), including recycling o

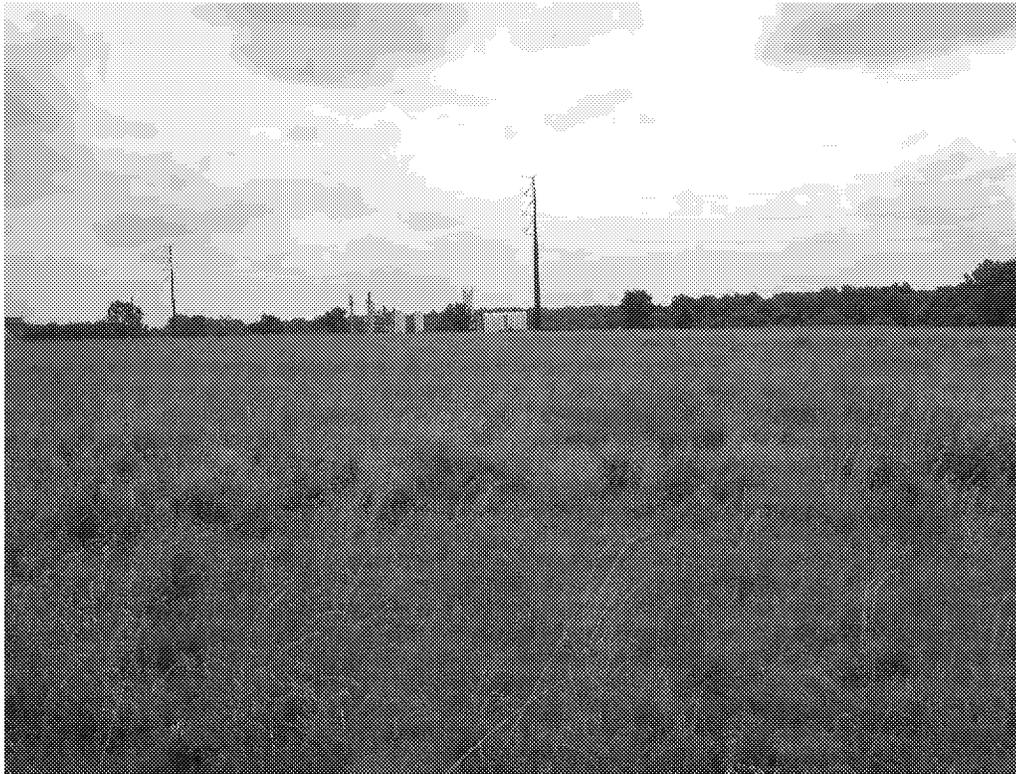
SWMU 8 Photograph 1: SWMU 8 (Landfill IV) is a 140-acre area that was the primary disposal site for solid and semi-solid wastes generated at the site. This photograph depicts center of Landfill A.

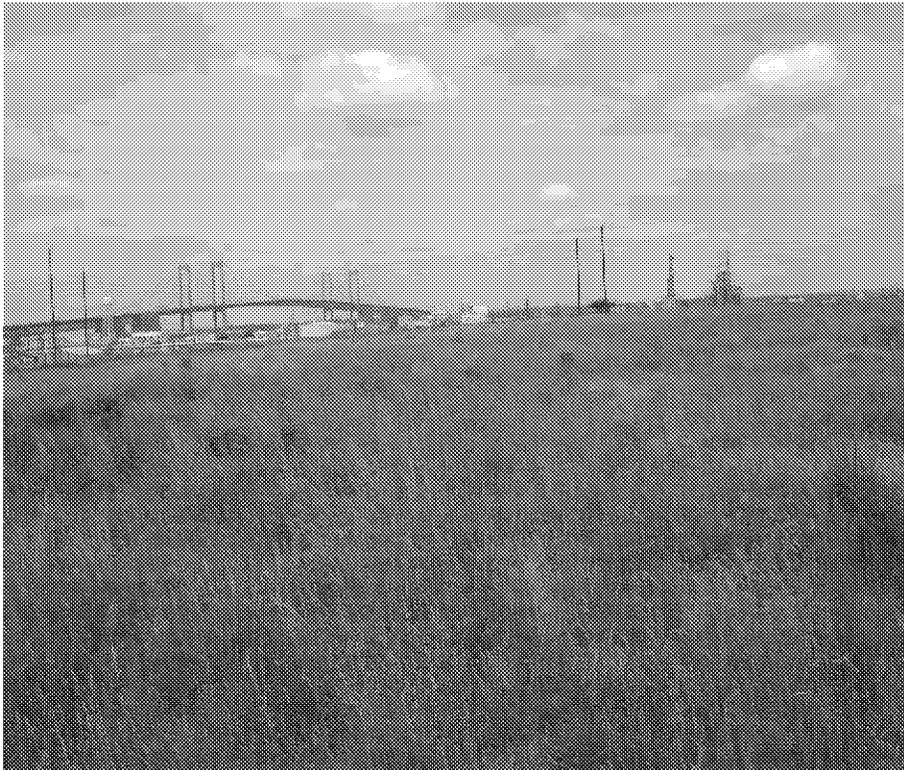
SWMU 8 Photograph 2: This photograph depicts the Southwest Corner of Landfill A.

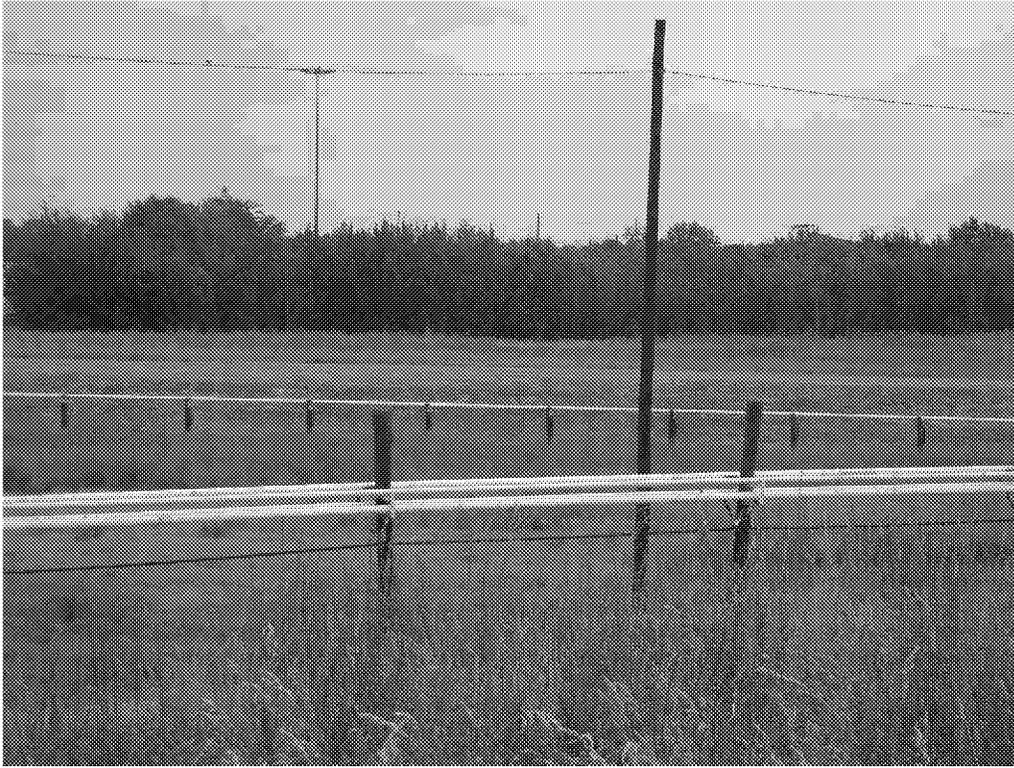
SWMU 8 Photograph 3: This photograph looks north from Landfill A.

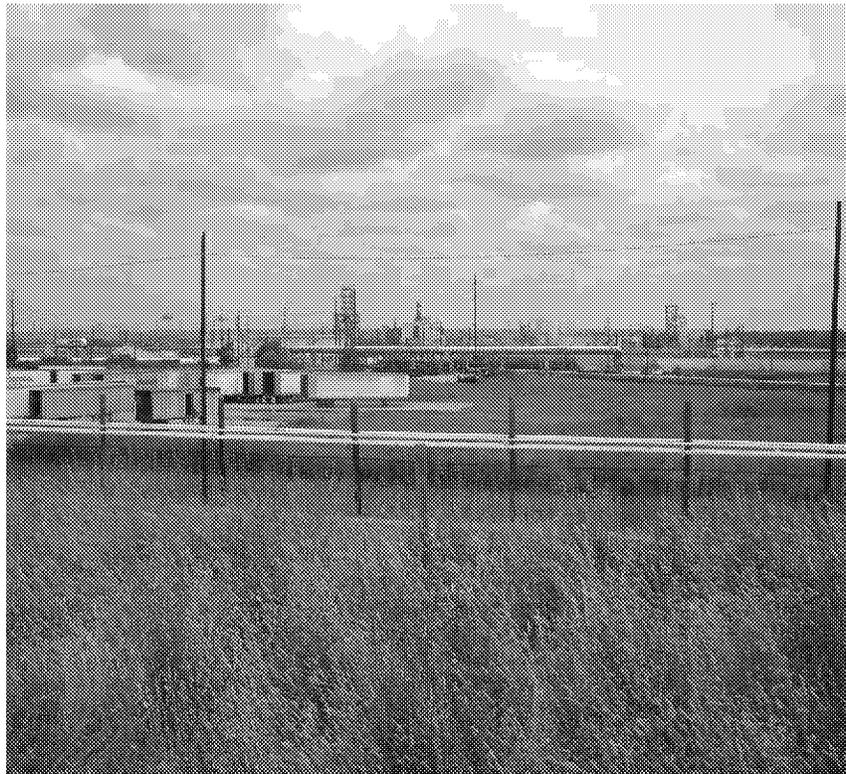
SWMU 8 Photograph 4: This photograph is taken from the northwest corner of Landfill A, looking at the northwest corner of SWMU 8.

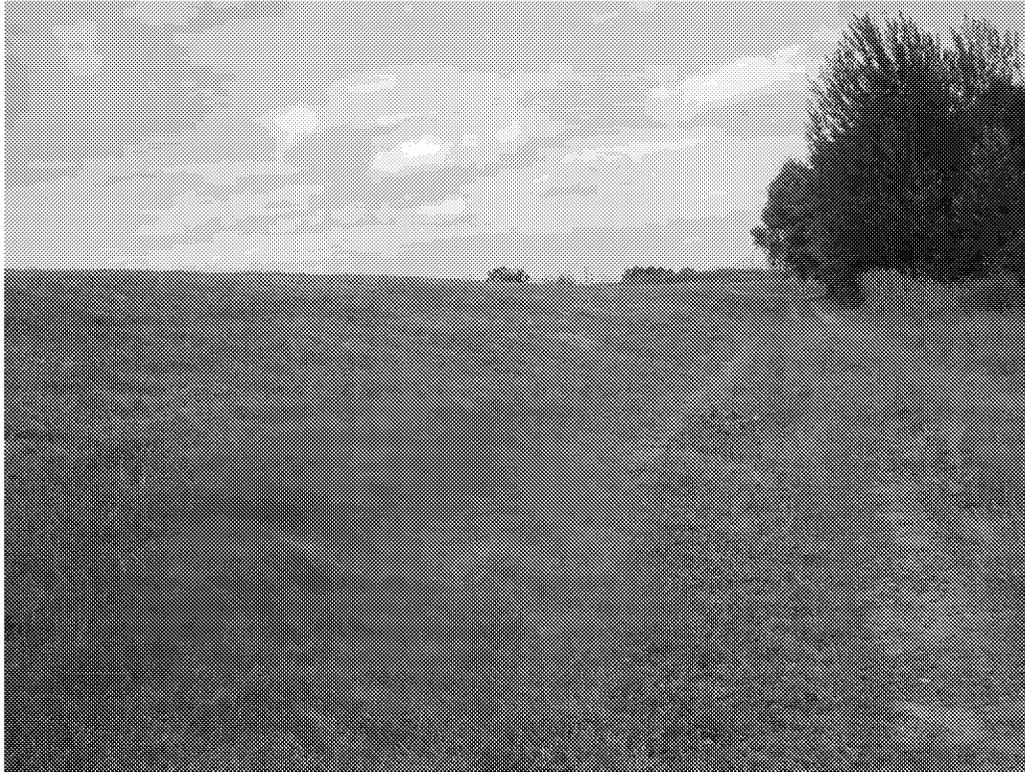
SWMU 8 Photograph 5: This photograph is looking southwest towards Landfill B.

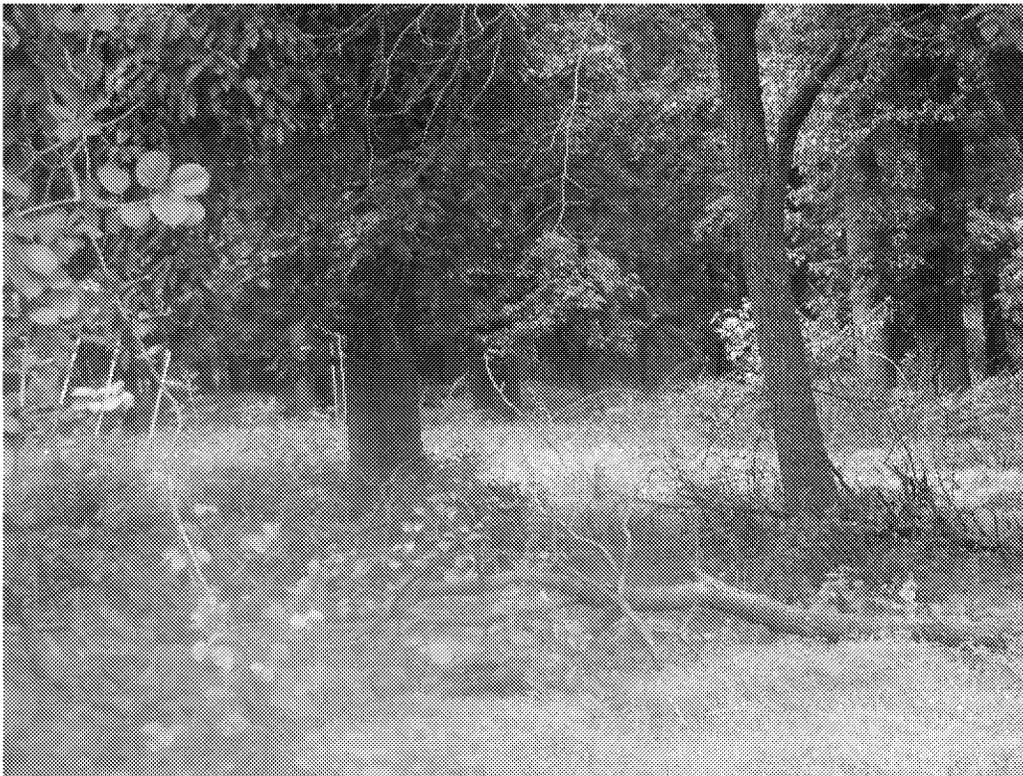
In addition, an additional forested area (11.3 acres) is located within the traditional boundary of SWMU 8. This area is not believed to be impacted because no manufacturing or waste management activities were conducted there.

SWMU 8 Photograph 6: This photograph depicts a forested area located at the southeast corner of SWMU 8.

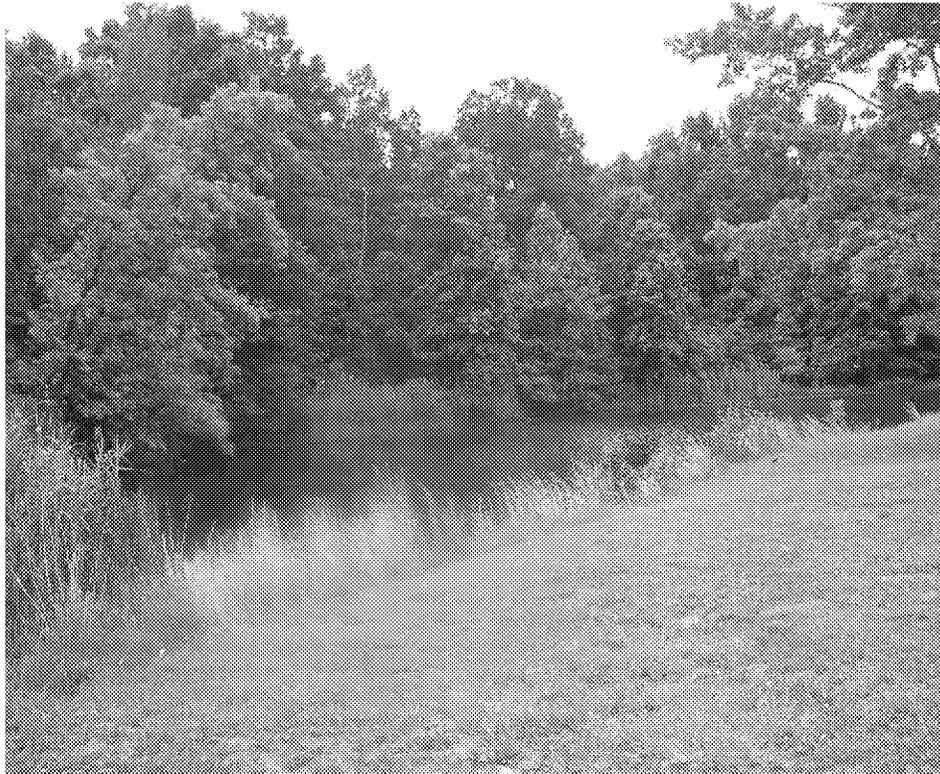
Two surface-water features (C and D Ponds) located within SWMU 8 were evaluated, and results were presented in the Ecological Investigation Report (URS, 2009). No further evaluations were recommended for these areas.

SWMU 8 Photograph 7: This photograph shows a small pond, which is located in the southeast corner of SWMU 8.
